Mobile Intel® Pentium® 4 Processor-M

Specification Update

June 2003

Document Number: **250721-015**

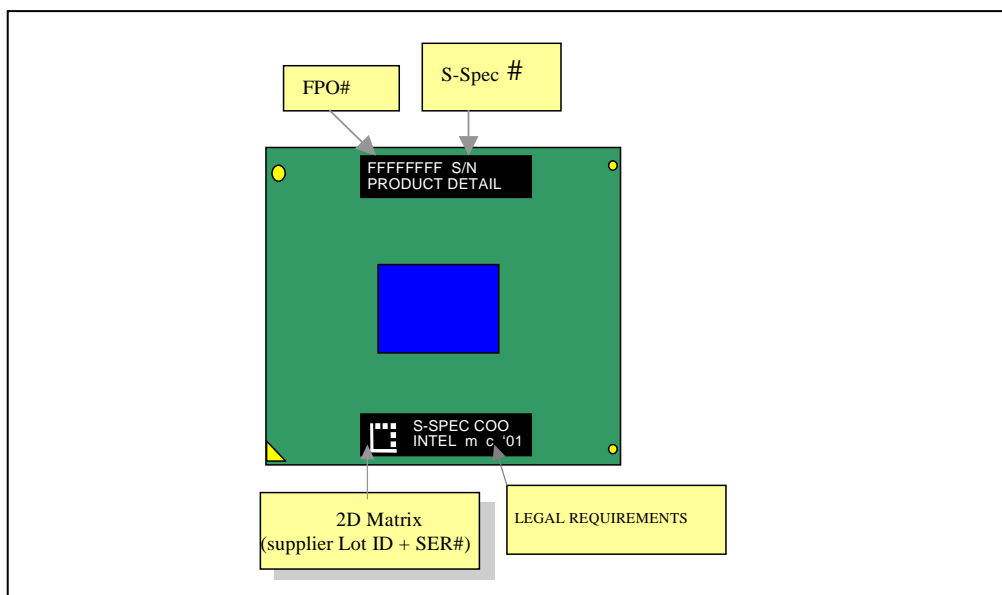
Figure 1. Mobile Intel® Pentium® 4 Processor-M (Micro-FCPGA) Markings

Identification Information

The mobile Intel® Pentium® 4 processor-M in Micro-FCPGA package can be identified by the following values:
